A conservation study of sandstone: the Church of Orsanmichele in Florence (Italy)

Teresa Salvatici¹, Marina Vieri de Miti¹, Irene Centauro¹, Sara Calandra¹, Eugenio Segabinazzi¹, Carlo Alberto Garzonio¹, Alba Patrizia Santo¹

¹*Department of Earth Sciences, University of Florence, Italy*

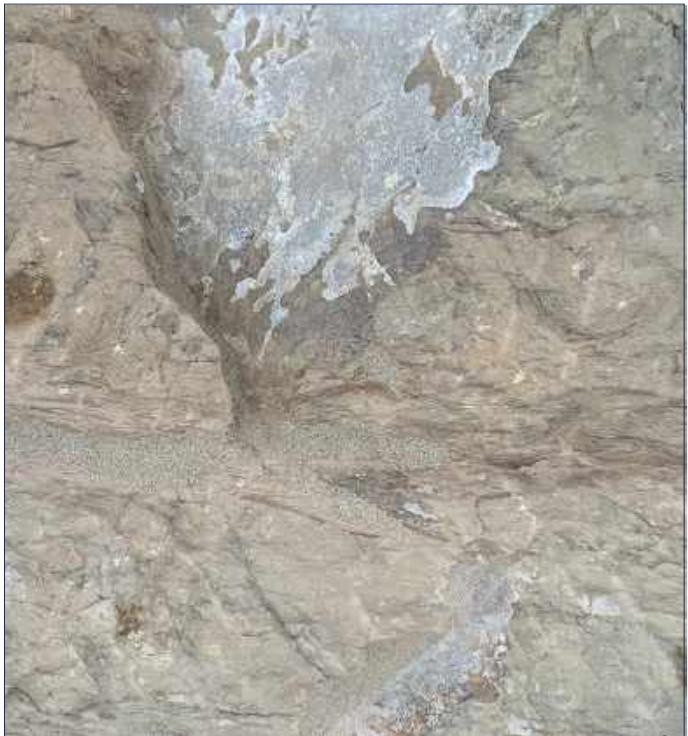
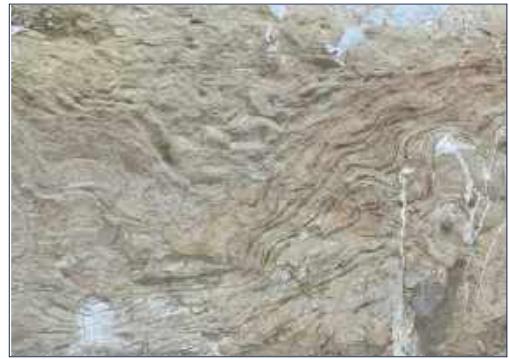
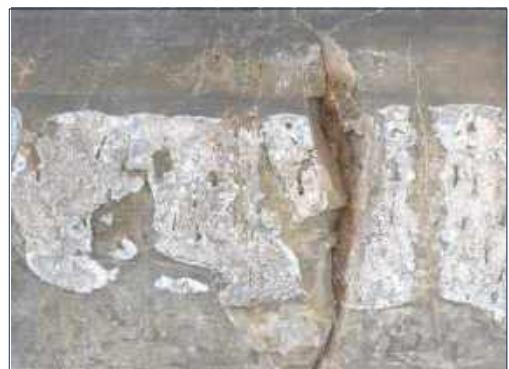
PIETRAFORTE

Convoluted laminations

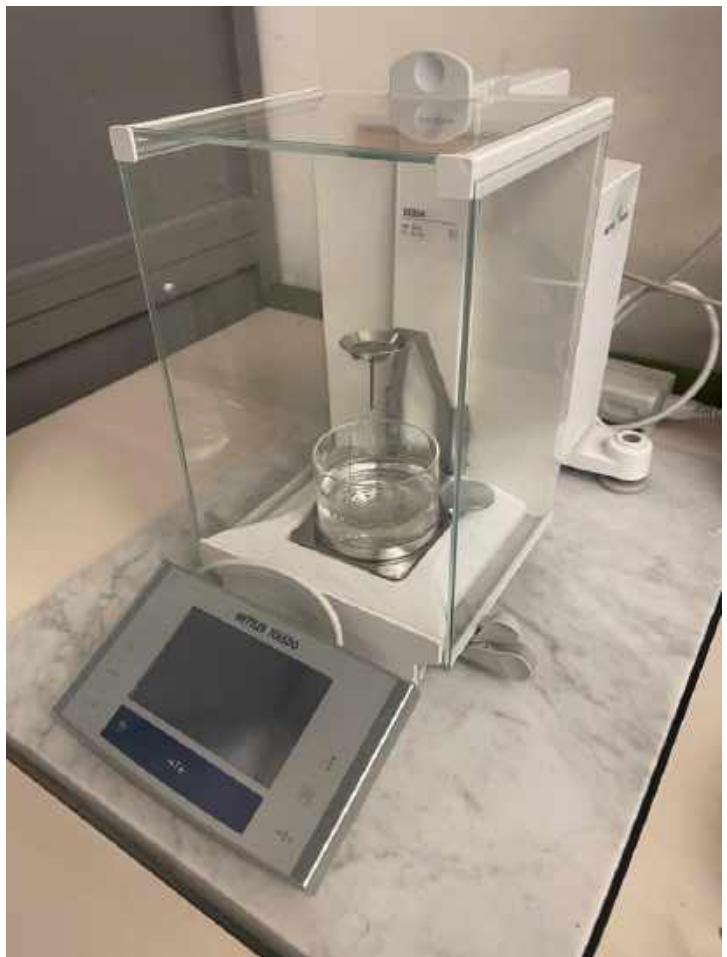
EX SITU INVESTIGATION

Physical results

Total open porosity of $7.61 \pm 0.21\%$,
 Water imbibition coefficient of $3.05 \pm 0.11\%$
 Apparent density of $2.59 \pm 0.01 \text{ g/cm}^3$.

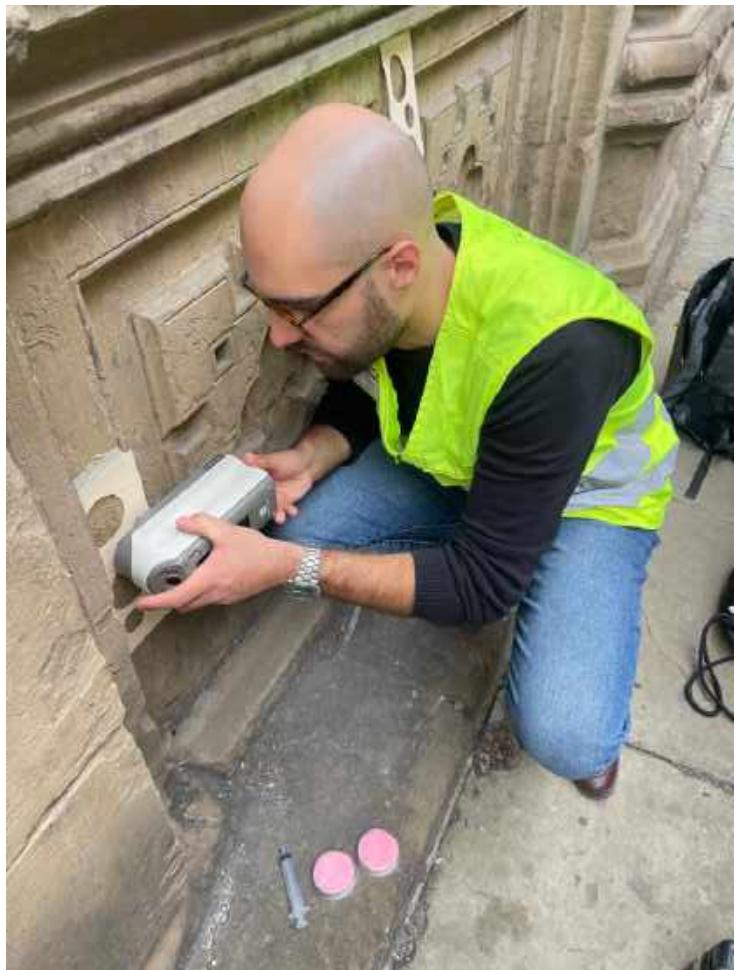
Colorimetry

- ✓ D65 illuminant
- ✓ 10° standard observer conditions
- ✓ SCI mirror- like components included
- ✓ Small aperture size (SAV) of 5 mm.

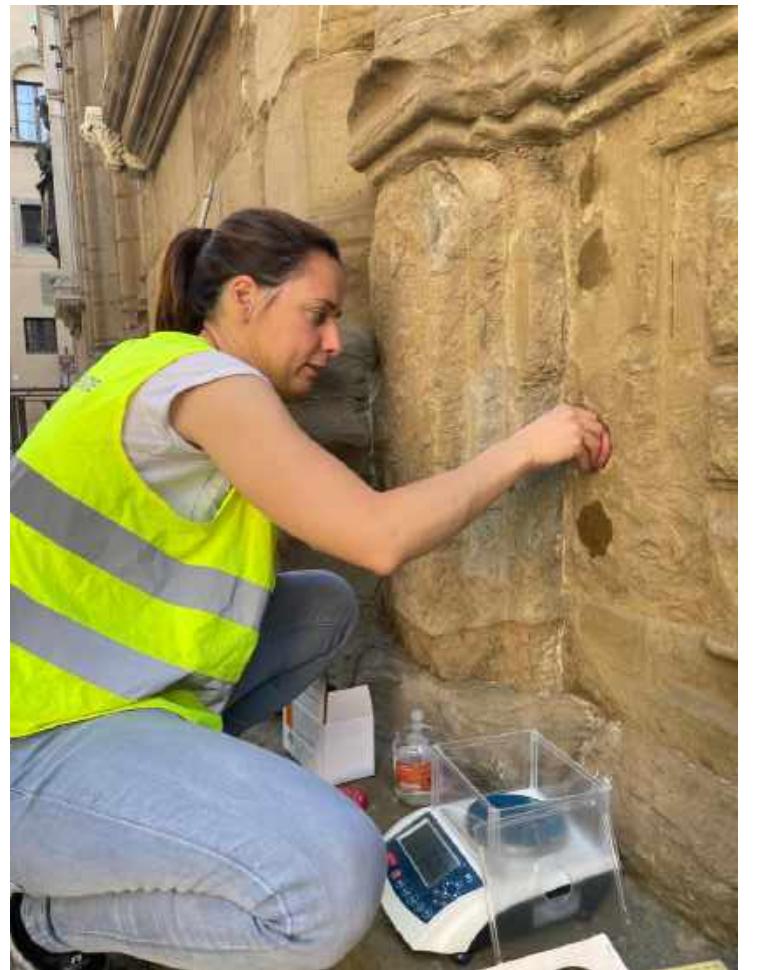
Contact sponge method

- Sponge diameter of 5 cm ✓
- Contact plate with a lid (1034 ✓
- Rodac®) ✓
- 15/16 g of demineralized water ✓
- 1 min to contact time ✓
